SERVICE REPORT

Vessel Name: NORDAMELIA

Job Description: No.4 Diesel Gen. Engine CMP-MAN 7L27/38, renewal of No.7 cylinder unit damaged parts by GC spares, replacement of complete turbocharger under GC No.162.

Our Job No: DCS-TR SERV-18M04-45

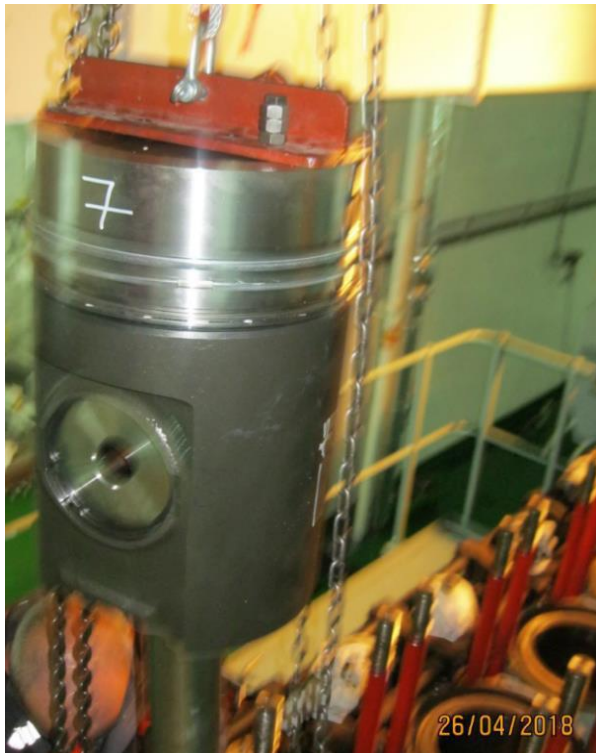
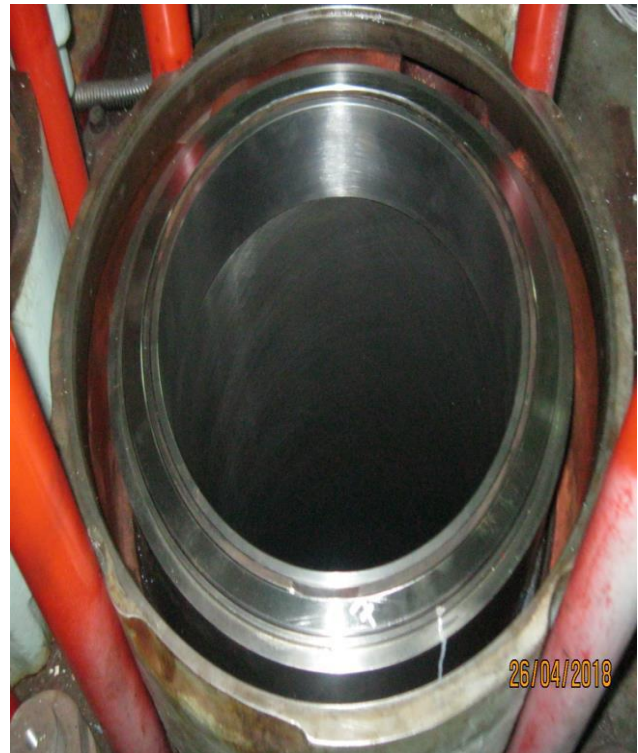
New piston and liner on No:7 Cylinder Unit

DCS team commenced dismantling of No.7 cylinder unit & installed new cylinder liner, flame ring & piston with new rings.

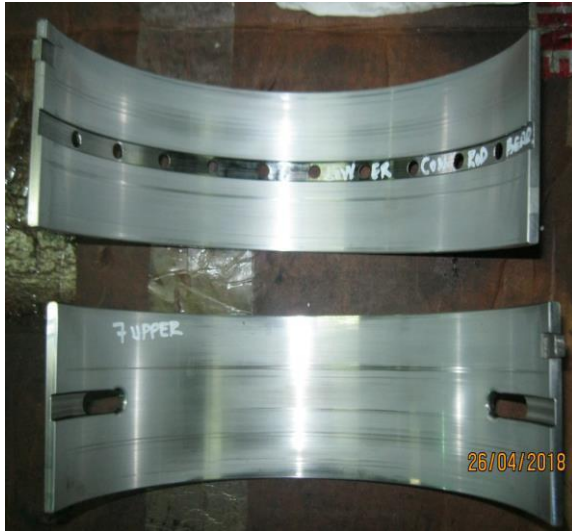
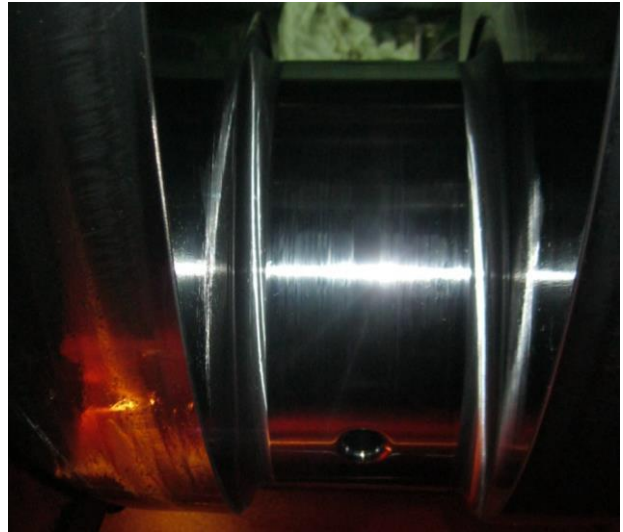
DCS teams had been dismounted No.7 Crankpin bearing & observed that No.7 Crankpin bearing & Crankpin journal is in bad condition showing circumferential scoring due to abrasive residues in lubricating oil. These type of scoring on crankpin bearing & crankpin journals shows engine worked with dirty oil for sometime to get this kind of a damage. Oil treatment on board should be immediately improved, Lube oil purifiers , fine filters should be inspected & repaired if necessary.

No:7 Crank Pin and Bearing Condition

- 1) Before starting of engine; all Crankpin bearing & journals should be inspected, Crankpin journals should be superpolished, Crankpin bearings should be renewed.
- 2) Main bearings also should be inspected & main bearing journals should be polished if necessary subject to this inspection.
- 3) Lube oil treatment should be improved as hard abrasive particules & residues should not enter system oil. Lube oil filters should be inspected & reconditioned/renewed as necessary.

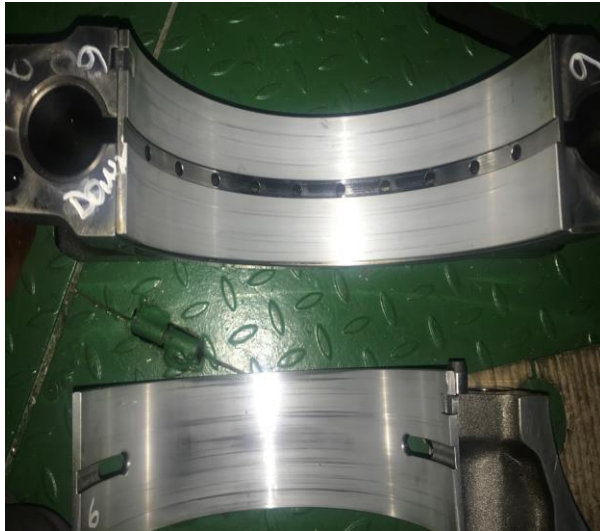
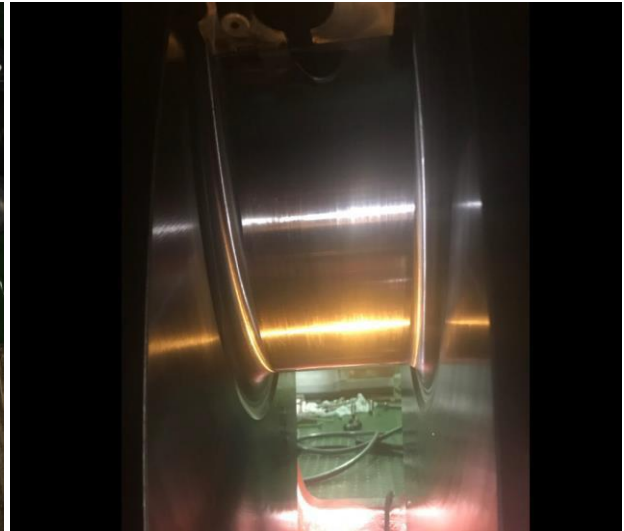
No.7 Crankpin journal & bearing condition had been reported to the vessel's Chief Engineer & to our Head Office. After receiving order to open up another 2 Crankpin bearing for inspections; team dismantled No:4 & 6 Crankpin bearing & observed same & more serious condition on these Crankpin bearings & journals.Both Crankpin journals which was inspected had been found showing circumferential scoring around the bearing /crankpin due to abrasive residues, hard particules in engine system oil .

No:6 Crank Pin and Bearing Condition

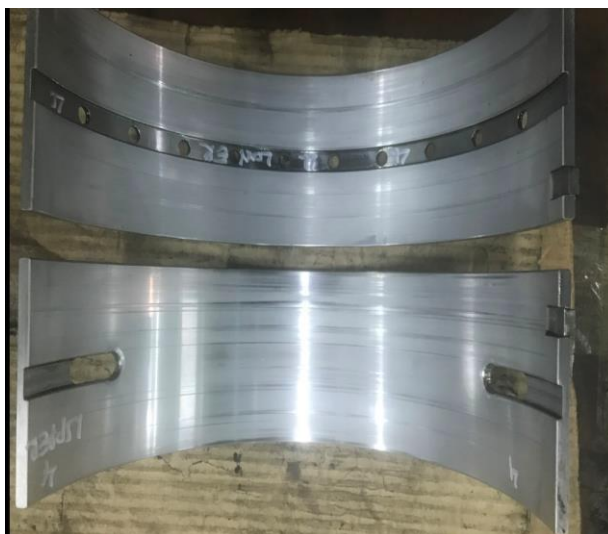
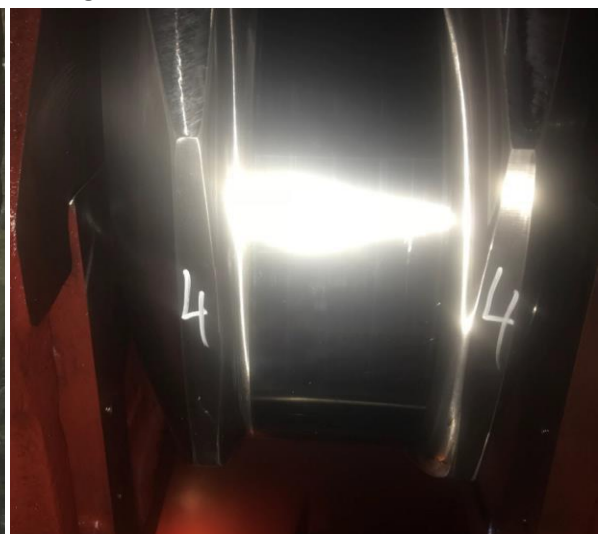
No:4 Crank Pin and Bearing Condition

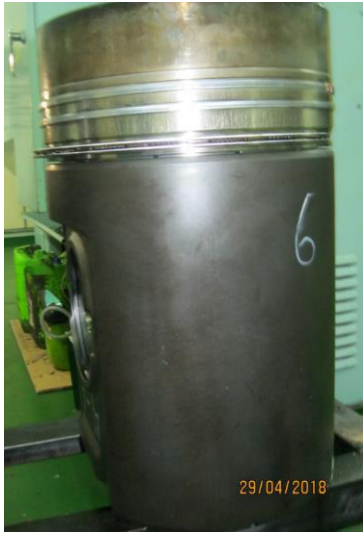
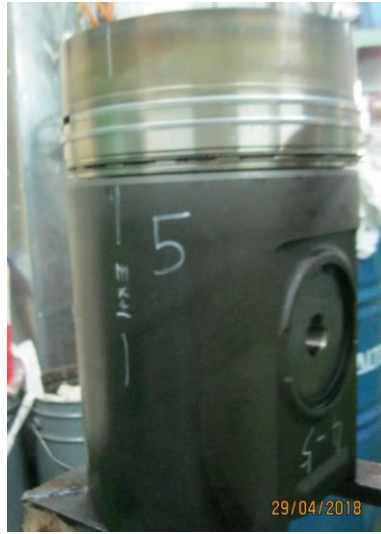
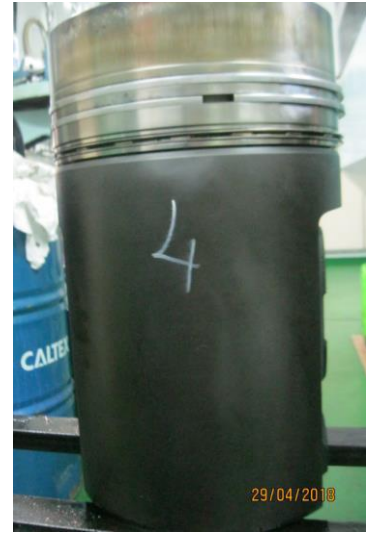
No:6, 5 and 4 Cylinder Unit Pistons

DCS team commenced fit back No.4-5-6 cylinder pistons & mount the Crankpin bearings of No.4 & 6 units.

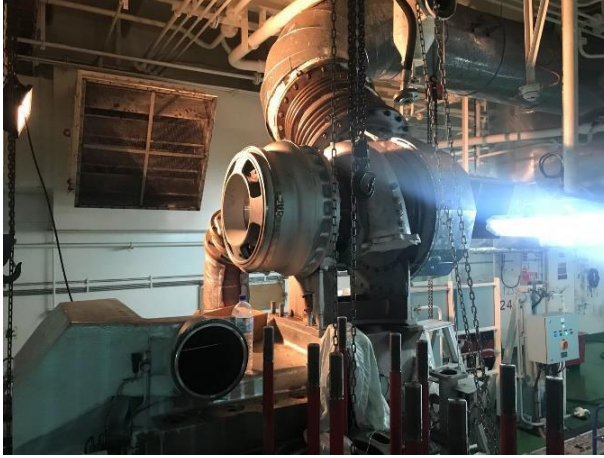
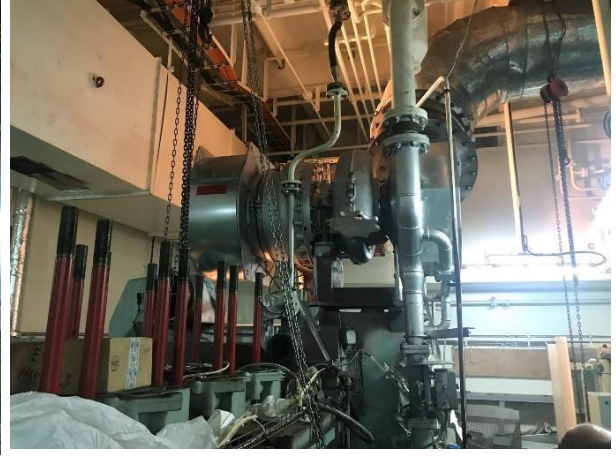
Damaged/New Turbocharger and Installation Works

After completion of No.7 Cylinder unit; teams commenced dismantling of Turbocharger & install new supplied Turbocharger on place. Pipe and other accesories fitted on turbocharger. Silencer protection kept fitted on it and before starting of A/E it should be removed from location.
